MECHANICAL ENGINEERING NOTE 387

AN EVALUATION OF ENGINE PERFORMANCE
ASSESSMENT PROCEDURES FOR THE LYCOMING
T53 ENGINE AS INSTALLED IN THE IROQUOIS
HELICOPTER

D. E. GLENNY

APRIL, 1981

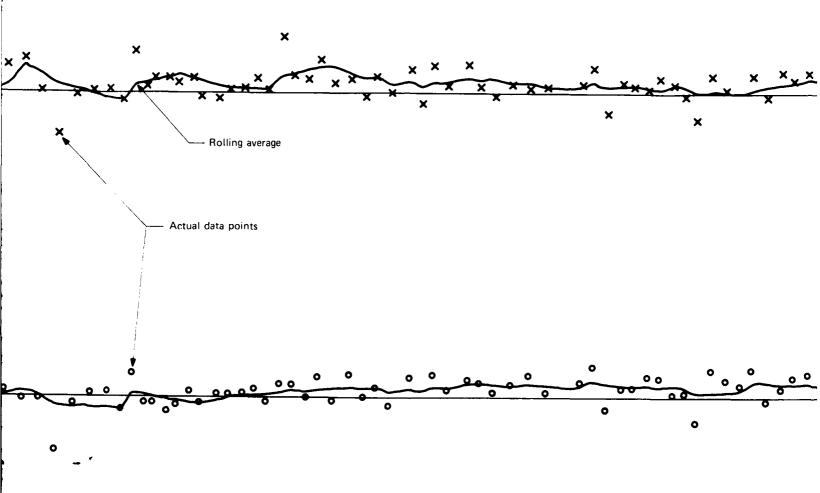
FIG. 3(d) DEVIATION OF OBSERVED EGT FROM BOTH SPECIFICATION AND ACTUAL BASELINE ENGINE PERFORMANCE

In Figure 3c and d a rolling averaging technique for each data point, defined by Δ_{RAS} at $n=(\Delta n+\Delta n-1+\Delta n-2+\Delta n+3+\Delta n-4)$ 5, was used to reduce the scatter in the results and give a smoother trend graph; the Δ_{RAS} results are given by the continuous line. The IFM results analysed in the EFDC, at RAAF Fairbairn, were also smoothed, but in this case the smoothing was obtained by dividing the data into groups each consisting of five results and then taking the average of each group. The effect of this technique can be observed in later presentations of the IFM results in Section 2.4.5.

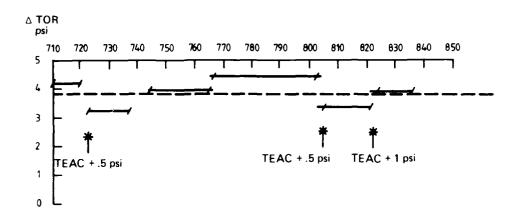
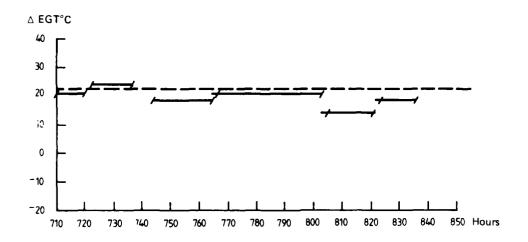
FIG. 7 IFM T53-L11 \vartriangle TOR AND \vartriangle EGT v TIME

- B. A similar consistency of results is shown in Figure 7 for 153-L11 engine (B model Iroquois aircraft). In this case however no engine deterioration was indicated by either the ΔTOR or ΔFGT trends. Limited cross checking with known TFACs as indicated on the figure, confirms that little if any engine degradation had occurred during the monitoring period. Comparison of ΔFGT trends with HTT data was not possible as at that time HTT procedures for L-H engines had not been introduced.

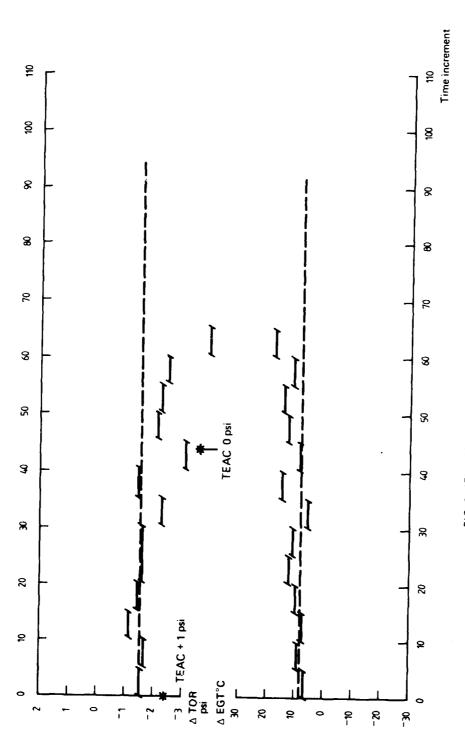
FIG. 8 IFM T53-L13 A TOR AND △ EGT v TIME

- c. The results given in Figures 8 and 9 are for two of the helicopters which were operated in the Middle East with the UNFF. The desert environment is particularly arduous on L-13 engines as can be seen by the marked fall off in torque levels for both engines. The EGT trends given in Figure 8 show a moderate rise in levels, whilst that in Figure 9 does not deviate, until the last 15 readings. At this point a maximum decrement of 42 C from the mean line can be observed, the change in EGT was immediately identified as a fault in the EGI harness). Analysis of the torque and EGT trends suggests that there had been a gradual change in the variable inlet guide vane (VIGV) scheduling. This conclusion was confirmed on servicing the engine when severe erosion and "roll over" was observed on the 1st and 2nd stage compressor blades. A modification to the leading edge section of the transome blades would, even though the VIVG actuation system was operating correctly, result in an effective change in the VIGV schedule. The torque trends determined from the IFM were confirmed by a number of TFACs undertaken during the monitoring period. These are also indicated on Figures 8 and 9. The TEACs for the engine given in Figure 9 are complicated by the fact that a Fuel Control Unit change was made during the course of the IFM and the effects on torque level have had to be compensated for. It is perhaps unfortunate that no HIT results were available, even though it is understood that HIT monitoring was being carried out whilst the aircraft were being operated in the Middle East. For if the HIT trends had mirrored the HFM-EGT trends, and reliance had been limited to HIT trends alone then the severe compressor wear indicated by the changes in the IFM torque levels would not have been picked up.
